2020 Update to the Site Discharge Pollution Prevention Plan, Revision 1

NPDES Permit No. NM0030759

May 1, 2021

Sandia/Mortandad Watershed

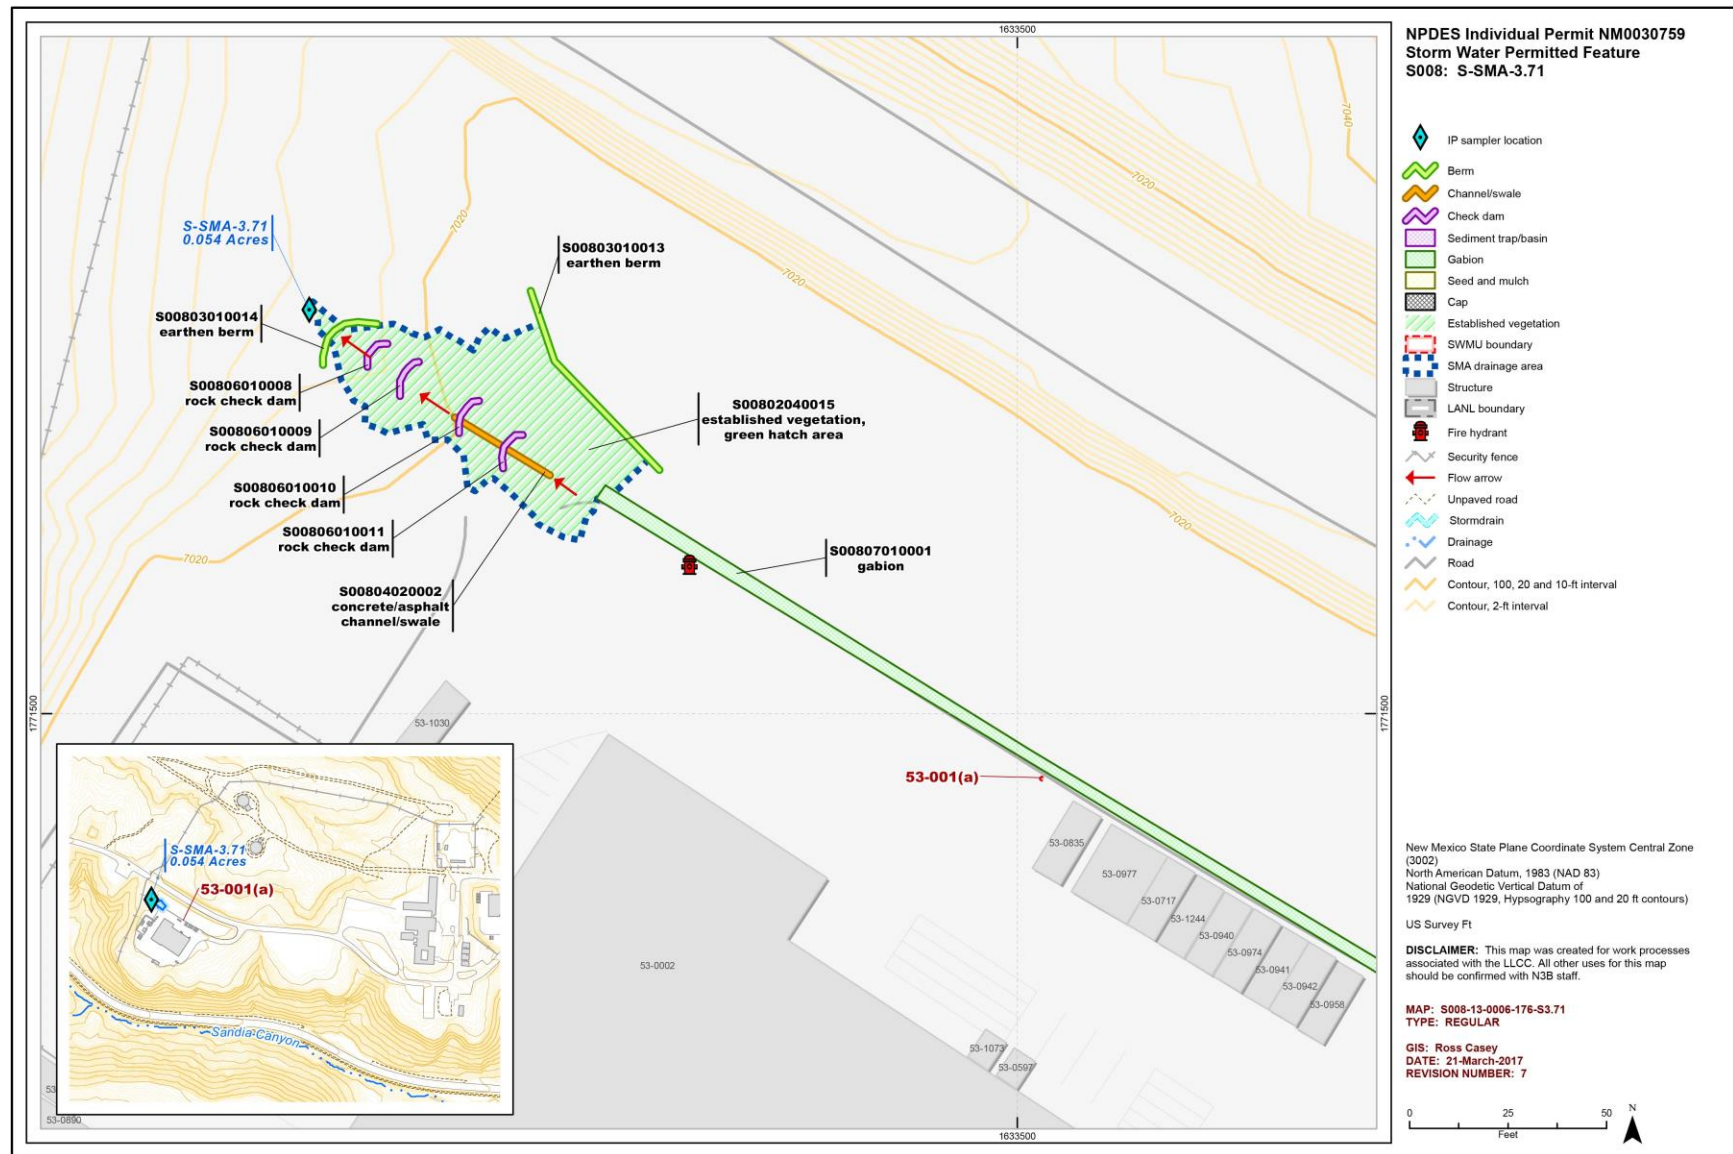
S-SMA-3.71, Rock Check Dam, S00806010008 (photo ID 8515-2)

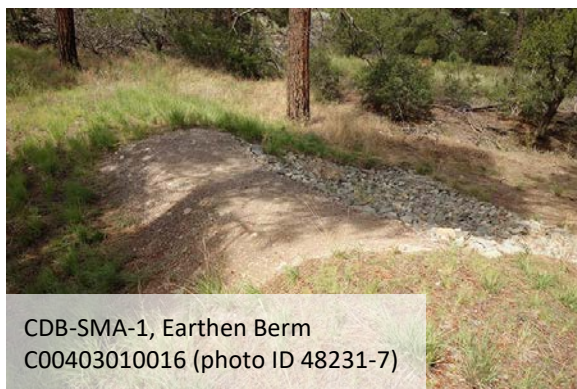
CDB-SMA-1, Earthen Berm
C00403010016 (photo ID 48231-7)
